RE: Powder Springs Road Plating
Austell, Cobb County, Georgia
Preliminary Assessment Report

**PRELIMINARY ASSESSMENT
POWDER SPRINGS ROAD PLATING
AUSTELL, COBB COUNTY, GEORGIA**

June 2019

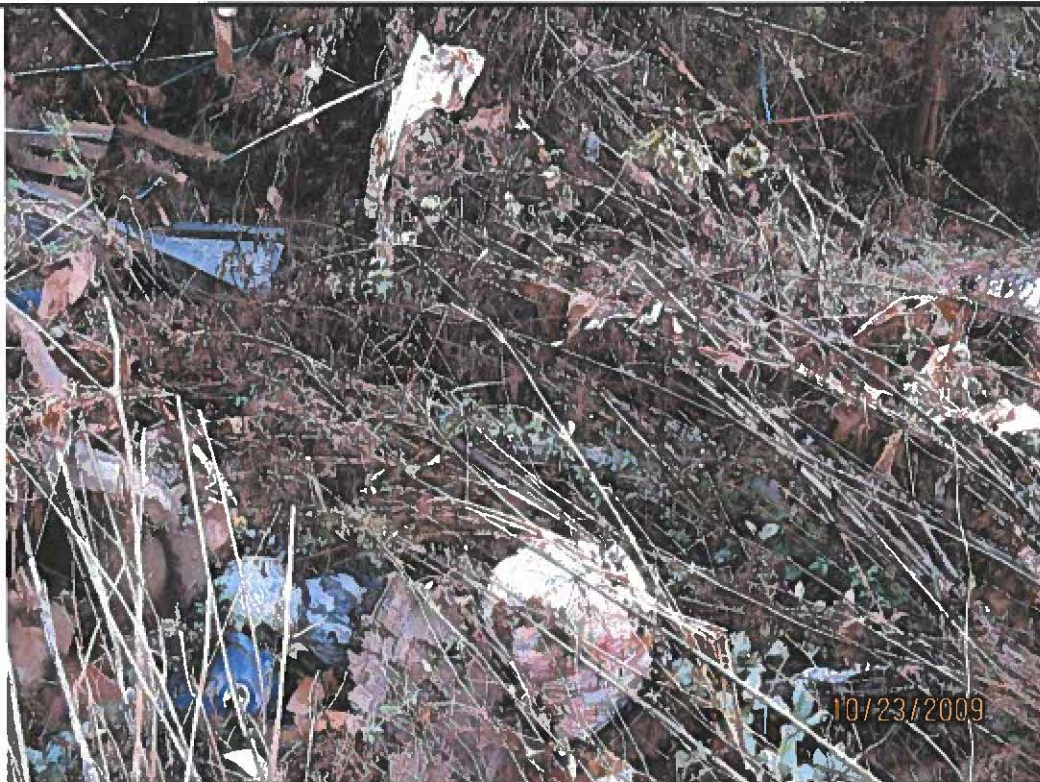
Explanation: Debris near ephemeral tributary.

On September 23, 2009 EPD conducted a complaint inspection of the facility. EPD arranged for Mr. Sawyer to meet with EPD at the facility to confirm that the facility condition was unchanged since the county site visit. At 1400 hours Rick Hardy and John Fonk of EPD met Daryl Sawyer and Travis Neumiller at the facility. It was raining at the time of the inspection. The security fence was knocked down by the flood waters so access to the facility was unrestricted (Photo 1). A pool of dark red-brown liquid with a yellow/green halo believed to be Chromic Acid was observed to be emanating from the building out onto the asphalt parking apron (Photos 2-5). EPD checked the brown liquid as it exited the building with pH paper and found the pH to be 3. Discolored runoff from the pool, mixed with rainwater, was traced down gradient (northeast) across the asphalt surface for over 100 yards toward the ephemeral tributary. Numerous puddles of the discolored liquid were noted along the surface water pathway (Photos 6-10 and 12). The asphalt surface was cracked and broken (Photos 9 and 10). At the end of the asphalt, the surface water pathway continued into a field through which flowed the unnamed tributary to Sweetwater Creek (Photo 53). The field contained one full (Photo 11) and two partially full totes estimated at 275 gallons each (Photos 54-55). There were also a few containers of undetermined condition mixed with debris far back in the weeds near the ephemeral tributary (Photos 55-58).

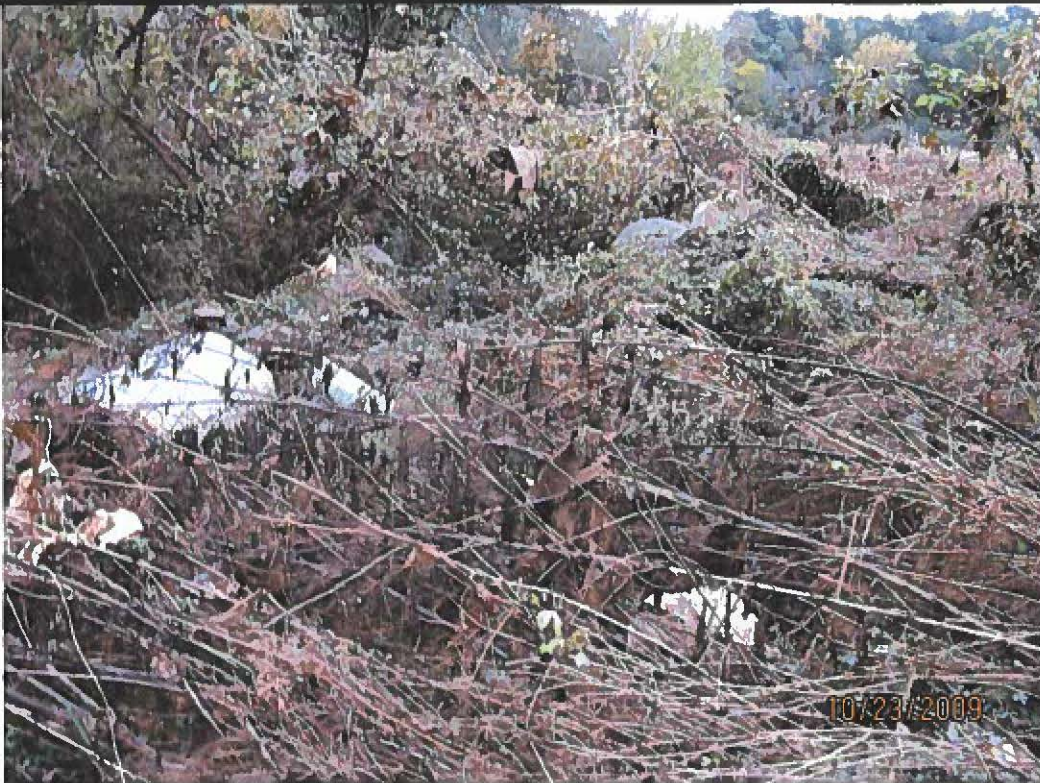
Explanation: Debris near ephemeral tributary. Note drum photo bottom left.

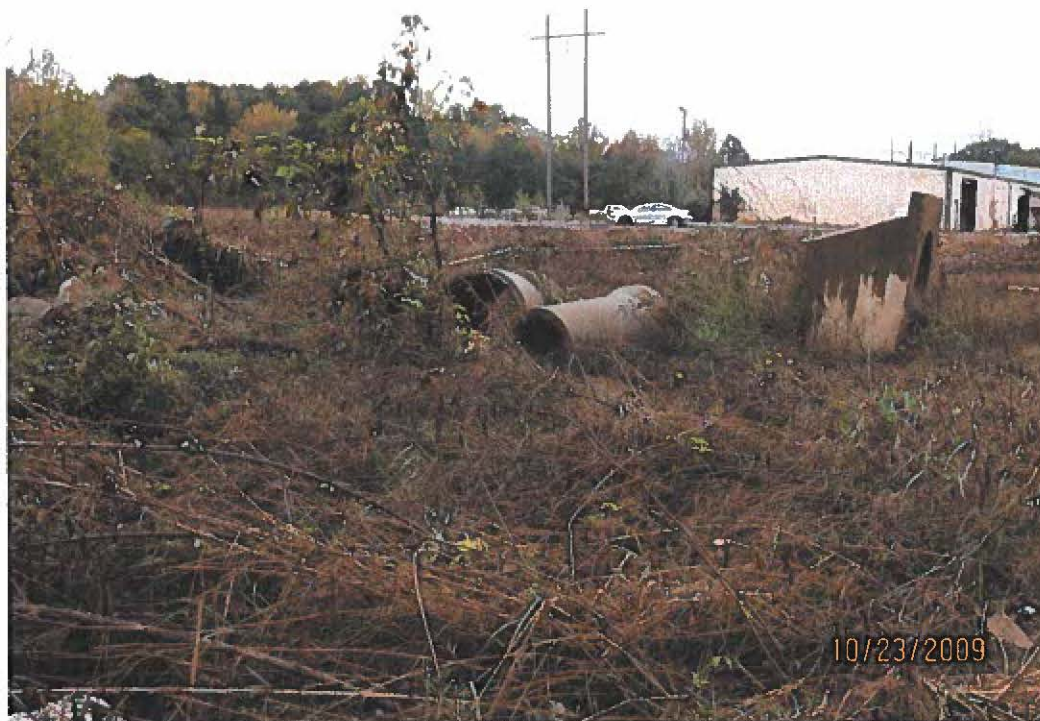
Explanation: Debris near ephemeral tributary. Note 275 gallon tote, photo left.
